# Structural testing and numerical simulation of a 34 m composite wind turbine blade

A full-scale 34 m composite wind turbine blade was tested to failure under flap-wise loading. Local displacement measurement equipment was developed and displacements were recorded throughout the loading history.

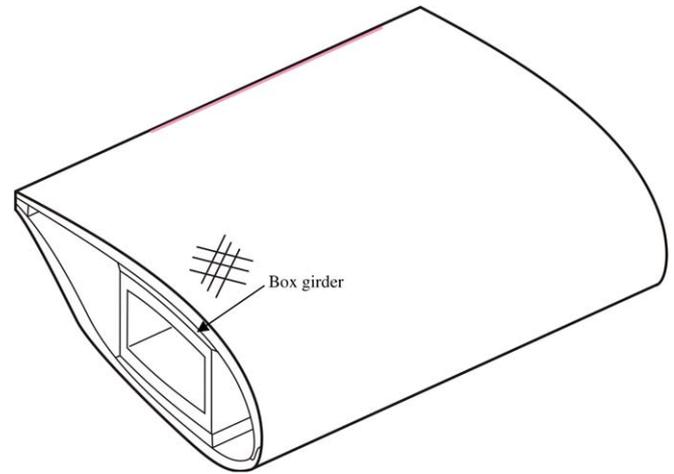
Fig. 2. Blade with a load carrying main spar.

A full-scale 34 m wind turbine blade, manufactured by SSP-Technology A/S, was tested to failure under flap-wise loading as shown in Fig. 1. The blade had passed all static and dynamic (correspond to 20 years life time) tests required by the classification bodies. The SSP-blade is made of glass-epoxy pre-preg material and is designed with a load carrying box girder, see Fig. 2.

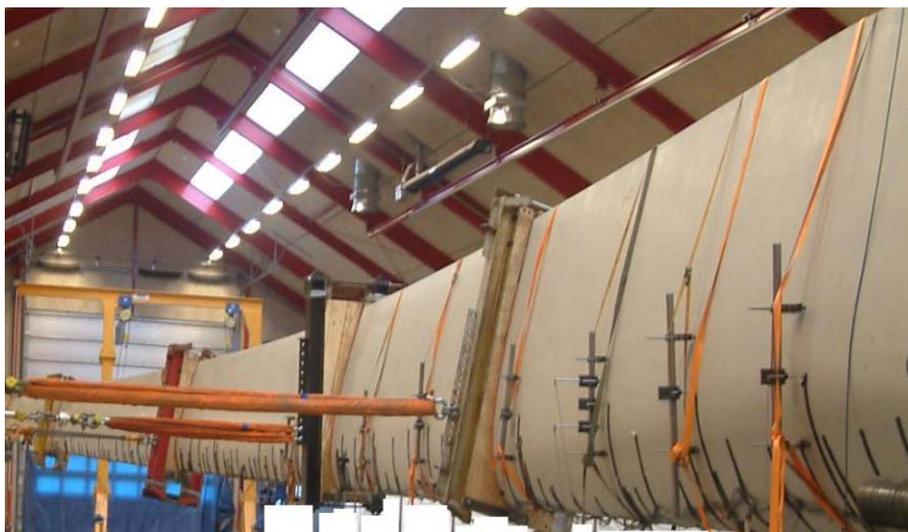
Fig. 1. Full-scale test – flap-wise loading.

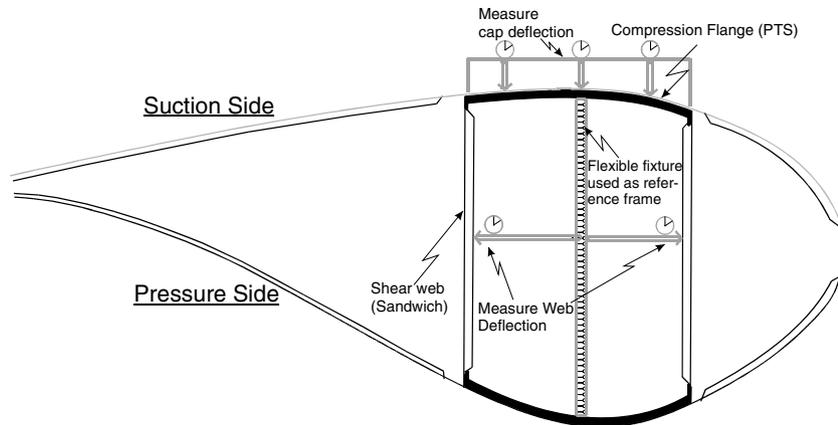
Fig. 3. Local displacement equipment in a blade section.

Earlier experience from another full-scale test [1] and FE-simulations [2] has shown that the cap deflect non-linearly. The conclusion from these investigations is that the load carrying box girder ovalizes when the blade bends flap-wise. New equipment has been developed to record the web deflection resulting from ovalization, see Fig. 3.

Deflections at the centre of the upper spar cap have been measured at seven different sections. In the section 10.3 m from the root, three chord-wise locations were measured, as shown in Fig. 3.

New equipment for deflection measurement was developed for use inside the box girder. The equipment is shown in Fig. 3 and measures local web deflections with a fixed reference frame in the centre of the box girder. The central reference frame is telescopic to allow for change in section height during ovalization of the box girder.

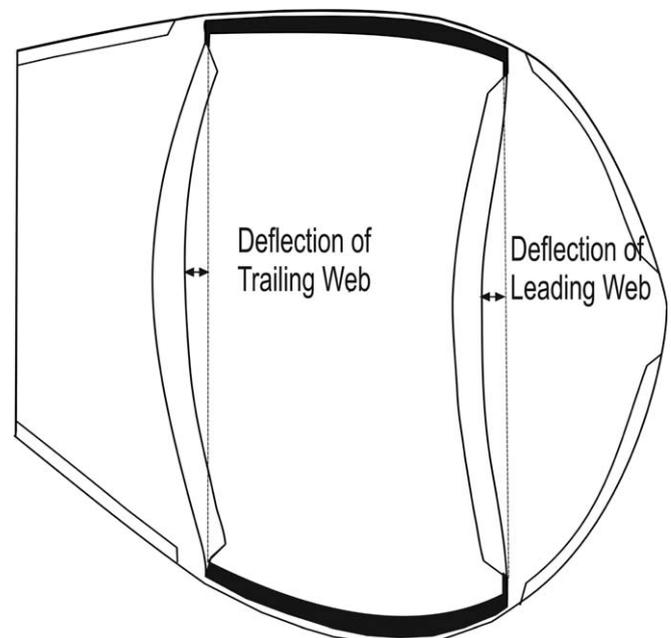
Fig. 4a. Sketch of non-symmetric.

A sketch of the non-symmetric web deflection is shown in Fig. 4a and measurements are shown in Fig. 4b. The measurements exclude deflections due to pre-load (gravity load) because the measuring gauges were reset prior to loading of the blade. The unusual behaviour of the webs is not discussed further here but is most likely related to the constraints imposed by the stiff root connection to the hub. In the current context, it is merely of interest to be able to apply the correct boundary conditions on the segments further away from the root.

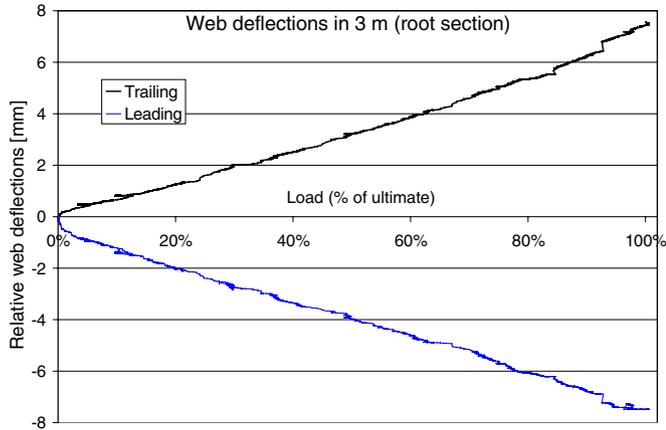
Fig. 4b. Relative web deflections versus load.

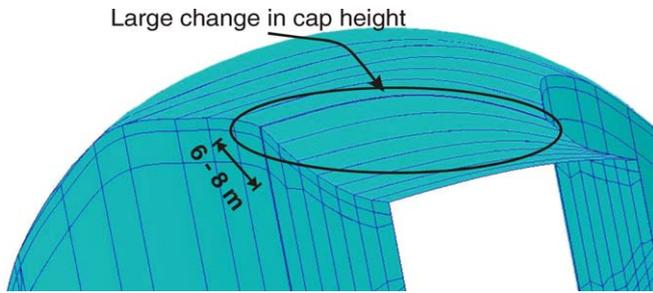
Fig. 5a. Changes in profile height.

A large change in cap curvature, and therefore cap height, takes place in the transition segment, see Fig. 5a.

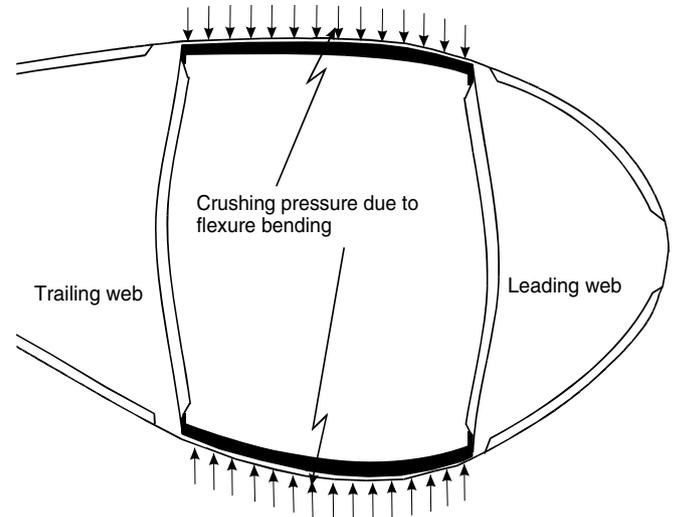
Fig. 6. Crushing pressure from the Brazier effect.

Box girder segment (8–34 m). In this segment the expected ovalization caused by flap-wise bending was observed. This non-linear deformation or “flattening” of the cross section is also known as the Brazier effect [1] and is most pronounced for long thin hollow beams

subjected to bending. The crushing pressure caused by the Brazier effect has a large effect on the web deflections and local deformation sensors have measured up to 20 mm displacement at the trailing web and 11 mm for leading web (Fig. 6).

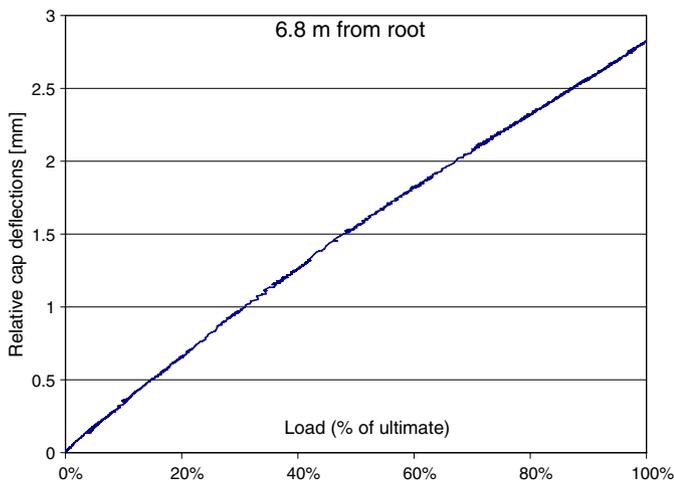
Fig. 5b. Outward cap deformation – measured.

Outward cap deformations were measured during the full-scale test as shown in Fig. 5b. These outward deflections were seen on the compression side of the blade and are linked to the rapid change in cap profile in this segment.

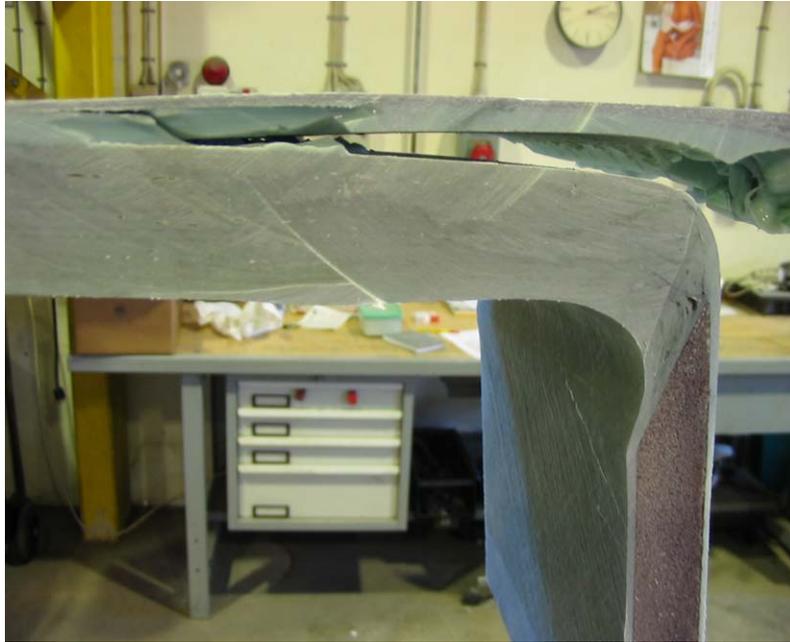
Fig. 7a. Skin peeling from cap.

Outer skin debonding from the box girder, see Fig. 7a, was observed after collapse, but it was not clear at which load this failure mode had occurred. A study of measured cap deflections has shown that the skin peeling starts at 92% of the ultimate load, see Fig. 7c. The jump in measured displacement is not due to sudden chord-wise bending of the cap, instead it was caused by the skin debonding from the cap where the skin assumes more of the initial curvature. The reference frame for measuring cap deflection is attached to the outer skin rather than directly to the box girder corner. Fig. 7b illustrates this observation. In Fig. 7c another skin peeling jump can be observed at 97% of ultimate load.

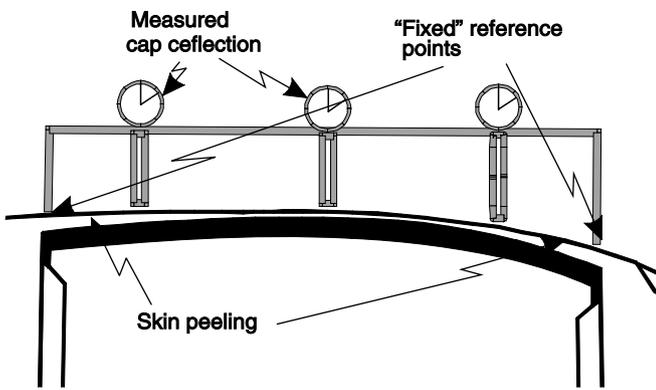
Fig. 7b. Reference points not fixed after skin peeling.

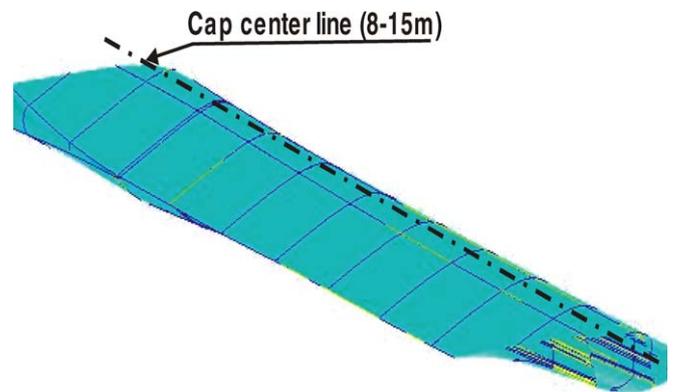
Fig. 8a. Cap centreline.

The cap centerline deflections were measured at four span-wise positions (8.5 m, 10.3 m, 12.5 m and 15.2 m) in the box girder segment from 8 to 15 m. A 8–15 m segment of the blade is shown in Fig. 8a with the upper cap centerline indicated. The measured cap deflections are plotted in Fig. 8b. Unfortunately no measurement was taken at

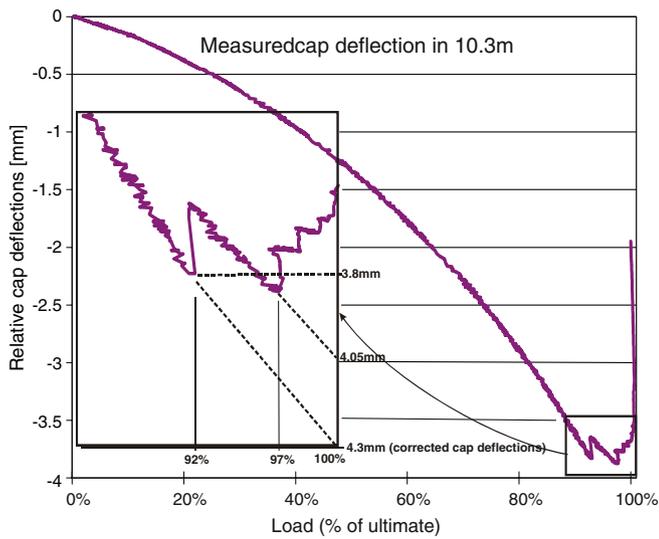
Fig. 7c. Measurements that show skin peeling and corrected cap values.

The actual maximum cap deformation of 4.3 mm was obtained by extrapolation, see Fig. 7c. This is the value that would have been observed if measurements were taken directly on the box girder or had debonding not occurred.

The skin debonding is expected to have a major influence on the final collapse. Buckling capacity of the blade is reduced dramatically once the outer skin and box girder separate. This buckling behaviour can be observed in Fig. 7c at 100% load, just before failure.

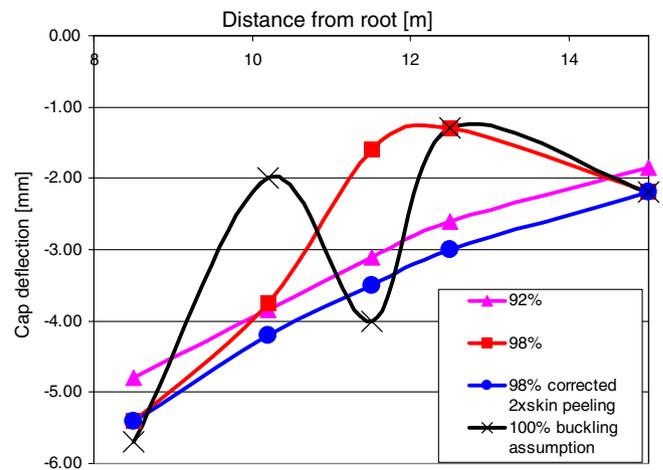
Fig. 8b. Cap deformation at different load levels.

11.5 m where the final failure occurred, so cap deformation at this section is assumed. If the deformation is corrected from the skin peeling mentioned above, the cap in the longitudinal direction behaves in a smooth manner until 98% load is reached. Above this load, most likely the cap starts to buckle as shown in Fig. 8b (dark line – 100% load). This assumption is based on two observations; pictures of the blade after collapse (as in Fig. 13) and the cap measurement in 10.3 m, 12.5 m and 15.2 m which fit into this buckling pattern, see Fig. 8b.

The buckling assumption does not take the clamp at 13.2 m into account, see Fig. 9. This approximation may affect the buckling pattern since the cap is not able to buckle outwards at this location while inwards deformation is unconstrained. The inwards displacement actually looks smooth and fits into the deformation pattern up to the ultimate buckling load, see the blue (●) and pink (▲) line in Fig. 8b.<sup>1</sup>

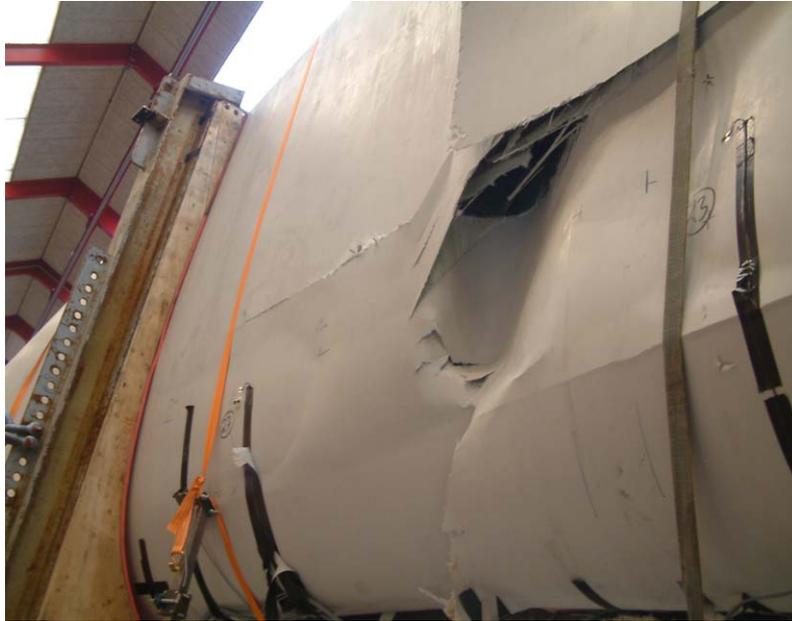
Fig. 9. Buckling collapse.

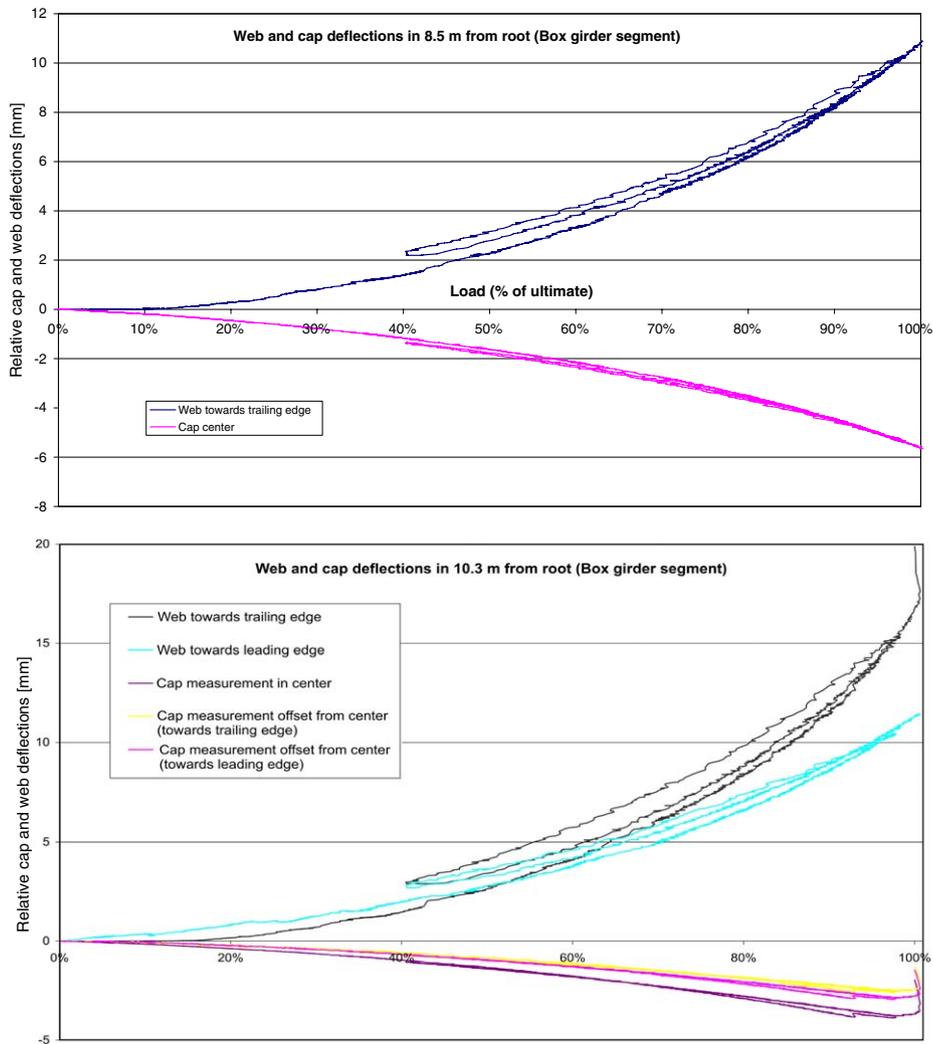
Fig. 10. Measured web and cap deflections at 8.5 m (top) and 10.3 m (bottom).

Measurements from both sections at 8.5 m and 10.3 m support the skin peeling assumption and the buckling assumption. At 92% load where skin peeling starts, there is no sign of sudden displacement jumps in the webs at either of the sections. Displacement jumps in the cap are seen at 10.3 m but not at 8.5 m. This ties in with what one would expect from skin peeling occurring at 11.5 m, i.e. only cap deflection is affected at the nearest measuring station. The web towards the trailing edge shows a moderate increase in deflection at the 8.5 m station and a much more pronounced increase at the 10.3 m station as the load approaches ultimate. This does to some degree also confirm that buckling occurs further outboard of the 10.3 m station. Alternatively, the web may have failed locally leading to buckling in the cap. Wing structures used in the aeronautical industry (helicopter blades and fixed aircraft wings) are usually designed with the trailing edge web stronger than the web towards the leading edge. Perhaps

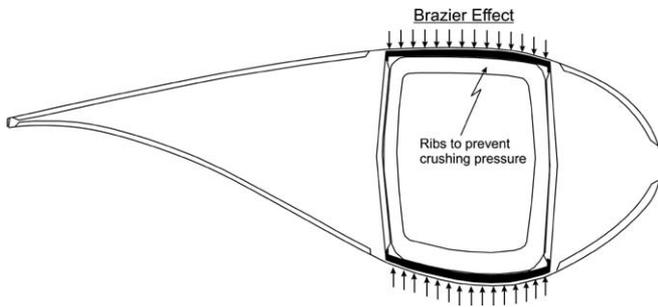
Fig. 11. Rib/bulkhead to prevent crushing pressure.

this should also be considered in the design of wind turbine blades. Another obvious difference between wind turbine blades and aircraft wings is the lack of internal ribs/bulkheads in the wind turbine blades. This should also be considered even though these ribs/bulkheads may add complexity to the manufacturing process. An example of how a web/bulkhead could be incorporated in the existing blade design is shown in Fig. 10 (Fig. 11).

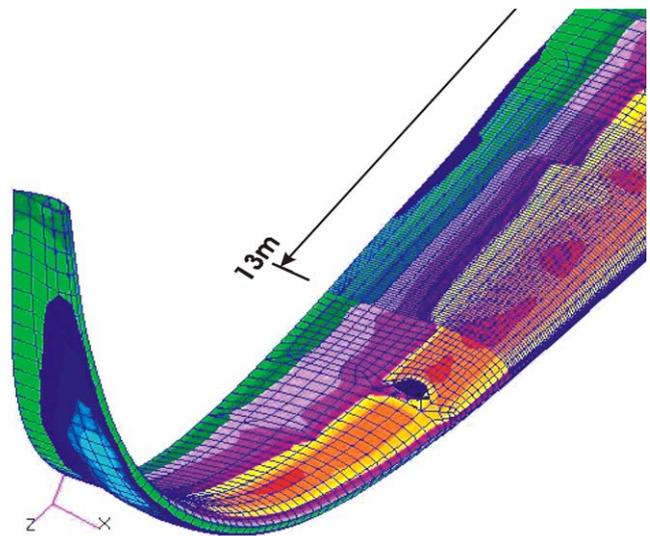
Fig. 12a. Global 34 m FE-model.

The main purpose of a global FE-model of the whole blade is to provide representative boundaries for the 0–13 m sub-model. Non-linear analysis is clearly necessary here due to the large deflections seen in the blade at higher loads. More interestingly, a combination of the anticlastic effect [3], which is a linear phenomenon, and the non-linear Brazier effect [4,5] seem to counteract one another at certain locations along the blade. At small loads the anticlastic

effect can cause outward cap deflection which then changes to inward deflection at higher loads as the Brazier effect (ovalization) takes over. This observation is illustrated in Figs. 12a and 12b. Linear analysis would simply not capture deflections due to the Brazier effect (Fig. 13).

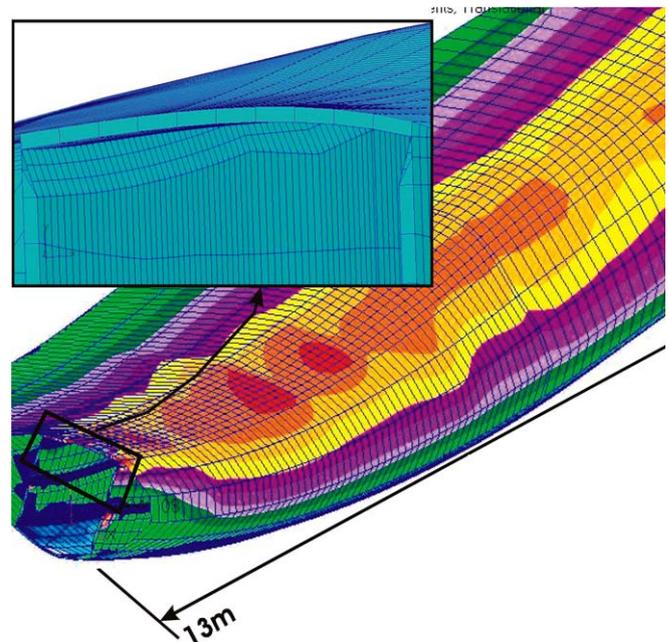
Fig. 12b. 0–13 m sub-model.

Capturing the correct deformation pattern required a more detailed sub-model of the 0–13 m section. The detailed sub-model includes solid elements in the webs and spar caps, see Fig. 12b.

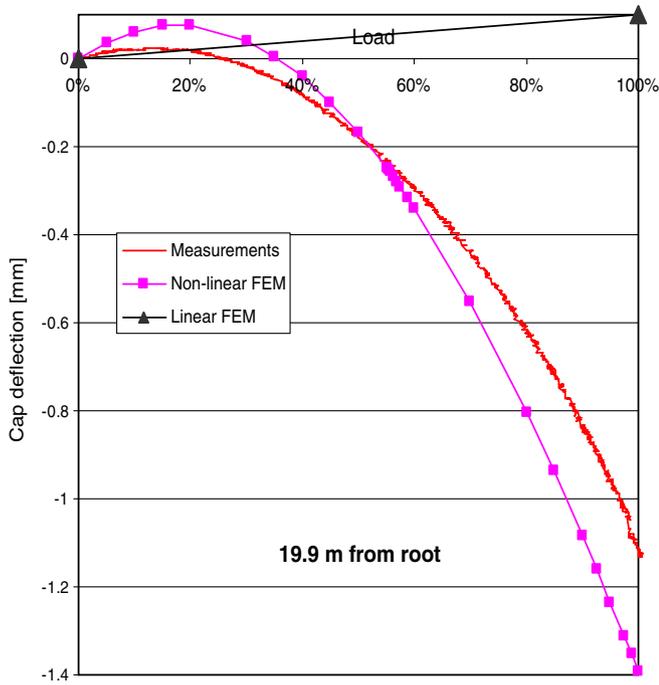
Fig. 13. Non-linear response in global model.

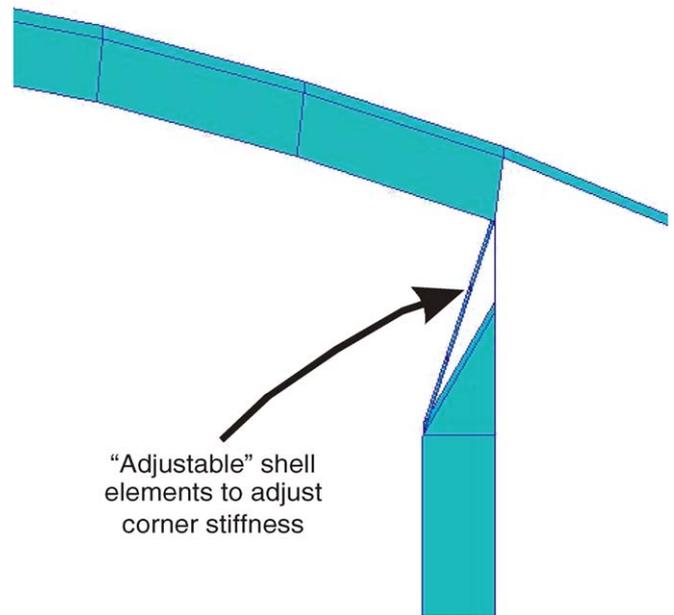
Fig. 14b. Box corner used for calibration.

Working with large wind turbine blades, made of fibre composites, a large margin of production tolerances must be accepted. SSP-Technology A/S uses a relative high quality production method (pre-preg without autoclave). Imperfections, such as voids, are most pronounced in areas where pre-preg layers terminate such as the corner of a box girder (Figs. 14a and 14b).

In principle all variations could be identified by cutting the blade into small pieces, measure the local stiffness, and then make a detailed FE-model which includes all these variations. In practise this is prohibitively expensive and a simpler approach was applied. Box girder corners in the FE-model were only represented with a coarse mesh of layered shell elements, which of course do not give the true picture of the corner stiffness. However, the modulus of an “adjustable” element was tuned to obtain the best fit with the actual deflections measured in the full-scale test.

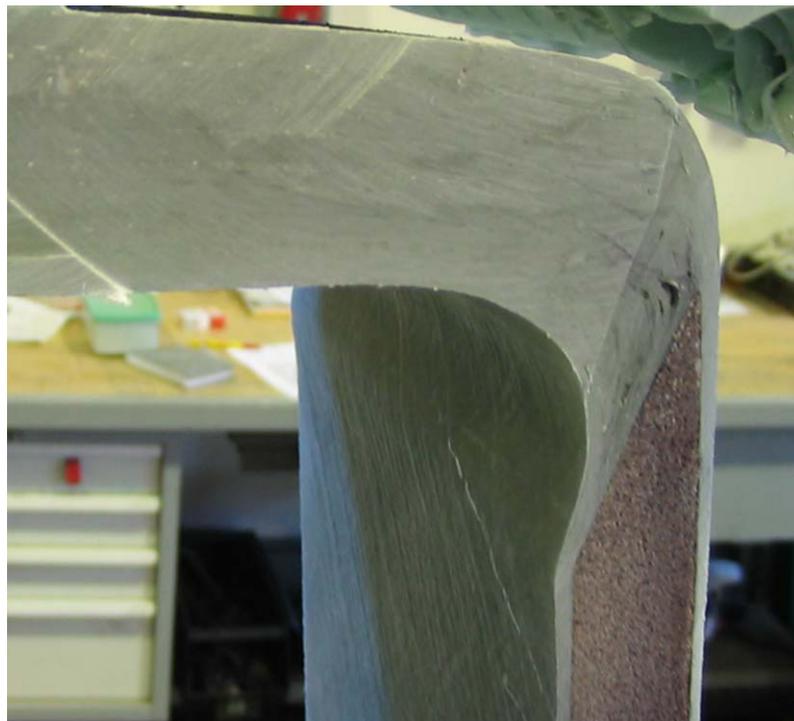
Fig. 14a. Section through a box corner.

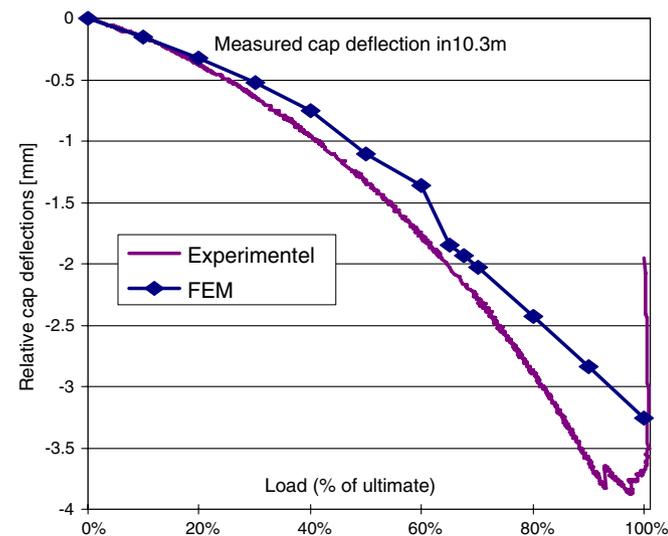
Fig. 15a. Comparison of cap deflections.

Comparing experimentally measured cap deflections with FE predictions, the agreement is found to be acceptable following calibration of the corner stiffness, see Fig. 15a. The web deflections, however, are not satisfactory above 80% load, see Fig. 15b. It was not possible to obtain better results by further adjustment of the corner stiffness and other improvements must be considered in the future work. It appears that a geometrical softening mechanism

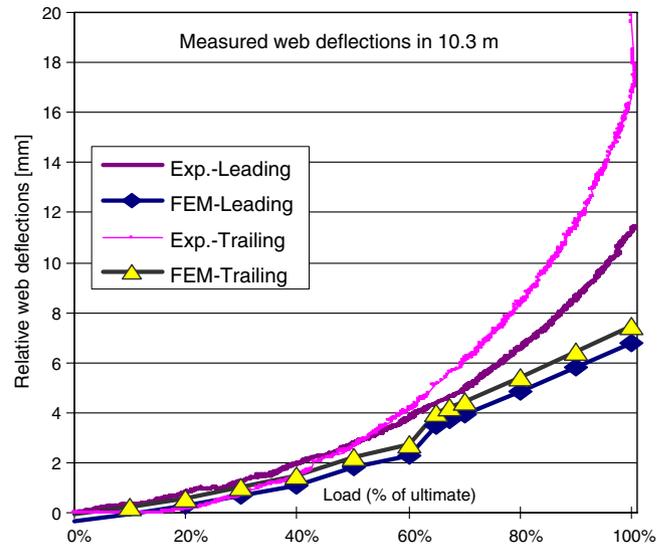
Fig. 15b. Comparison of web deflections.

or material non-linearity exists in the actual blade. This is not accounted for in the FE-model hence good correlation is seen at lower loads while the FE-model is over-stiff at higher loads approaching ultimate strength. Also, a kink is evident on the FE deflection curves at 60% load which is hardly noticeable on the curves obtained from the test. If certain features in the FE-model are too stiff it is conceivable that localized post buckling or snap-through has a more pronounced effect on the lateral deflections of the box girder. It should be mentioned that the overall flap-wise blade deflection shows exact agreement between test and FE-model. This is also the case for natural vibration modes, which are not included in this paper.
